Technical Report ITL-96-9 September 1996

Case Histories of Earth Pressure-Induced Cracking of Locks

by Robert M. Ebeling, Robert C. Patev, Reed L. Mosher

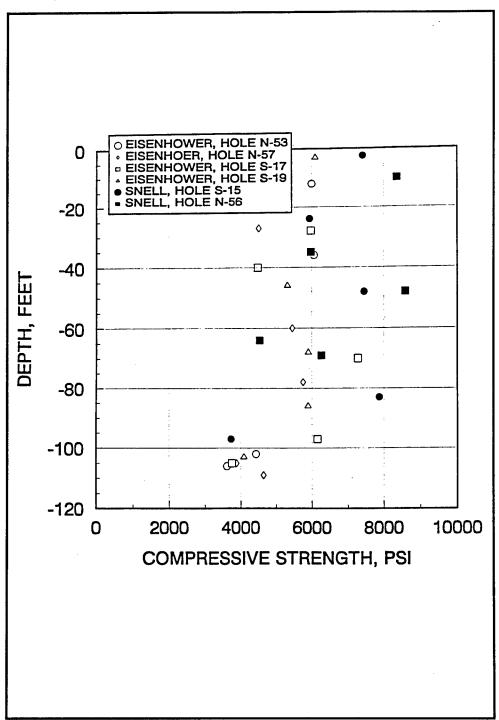
A second study of Eisenhower and Snell Locks was conducted in 1991 by Mosher, Bevins, and Neeley. Six-in.-diameter concrete cores were recovered over the entire height of six lock monoliths (four at Eisenhower Lock and two at Snell Lock). Figure 3 shows the compressive strengths measured on 19 samples taken from Eisenhower Lock and on 10 samples taken from Snell Lock. The compressive strengths averaged 5230 psi (range 4070 to 6050 psi) and 6620 psi (range 3730 to 8590 psi), respectively. The average compressive strength for the 1991 tests of cylinders taken from Snell Lock was more than 1000 psi greater than the average compressive strength measured in 1966. However, the average compressive strengths are nearly the same in the 1966 and 1991 studies for Eisenhower Lock.

The lower average value for compressive strength at Eisenhower from the Mosher, Bevins and Neeley (1991) study is biased because of the larger

Figure 3. Variation of concrete compressive strength with depth (from Mosher, Bevins, and Neeley 1991)

number of test specimens from the lower portion of the wall when compared with the number of specimens from Snell, six from Eisenhower and only one from Snell. Using the average compressive strength from specimens taken from the upper portion of Eisenhower borings and comparing that to the Snell average, the difference is only 9 percent, which is approximately the same difference reported by Buck, Mather, and Thorton (1967).

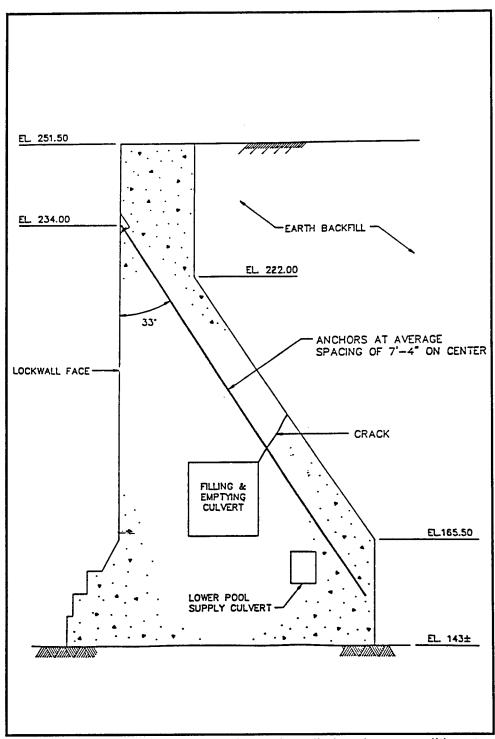
In January 1967 during inspections of the Eisenhower Lock filling and emptying culverts by Saint Lawrence Seaway Development Corporation and Corps of Engineers personnel immediately after winter dewatering, a continuous crack was observed along the landward-ceiling corner of the culvert in the north wall. Further investigation revealed that this crack was continuous from the culvert through to the exterior backfilled face of the lock wall. At the time, the crack leaked water in various amounts along its entire length, and fresh spalls of concrete were found lying on the culvert floor beneath it. Subsequent detailed inspections and other pertinent investigations revealed that the crack extended along the culvert between the upper and lower valve monoliths.

After initial discovery of the crack in the north culvert, a close inspection was made in the south culvert. The same kind of crack that existed in the north culvert was present in the south culvert at its landward-ceiling corner, as shown in Figure 4. Its longitudinal extent was the same as that of the north culvert crack. Examination of the Snell Lock culverts revealed similar cracks in that lock.

With these cracks extending through to the backfill, the overall stability of the lock walls became a matter of serious concern. Under certain conditions, all wall loads must be absorbed by the 15-ft-thick section between the culverts and the faces of the lock chambers. This was thought to be especially serious with respect to Eisenhower Lock where portions of this section were deteriorated and, thus, less capable of supporting the imposed loads. The core boring program underway concerning the

Figure 4. Typical section through south wall chamber monoliths at Eisenhower Lock

Priority was given to Eisenhower Lock. The rehabilitation work for the crack consisted of placing post-tensioned anchors across the culvert crack (both walls). This was accomplished during the winter shutdown of 1967-68 by contract with Peter Kiewit & Sons. Similar post-tensioned anchors were placed across the culvert cracks at Snell Lock during the winter of 1968-69 under contract with Morrison-Knudsen.

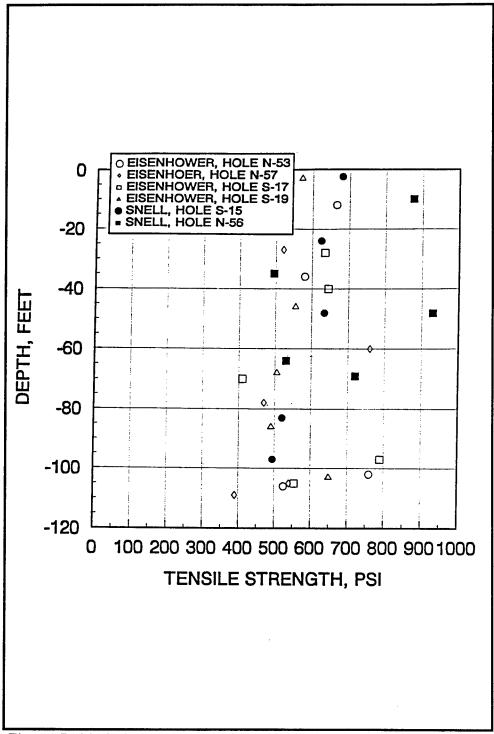
Thirty-one of the 6-in.-diameter concrete cores recovered in 1991 by Mosher, Bevins, and Neeley were used to measure the splitting tensile strength of the concrete that comprises the Eisenhower and Snell Locks. Figure 5 shows the distribution with elevation of the tensile splitting strengths measured on 21 samples taken from Eisenhower Lock and on 10 samples taken from Snell Lock. The tensile splitting strengths averaged 581 psi (range 390 to 790 psi) and 650 psi (range 495 to 930 psi), respectively.

Figure 5. Variation of concrete tensile strengths with depth (from Mosher, Bevins, and Neeley1991)

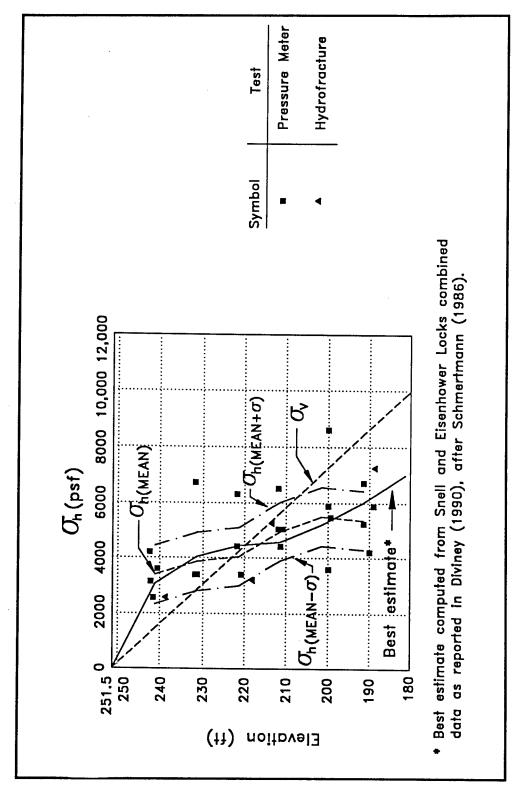
The statistical evaluations of the PMT test data shown in Figures 6 and 7 were made using weighting factors based on Schmertmann's interpretation of the data. Schmertmann's interpretation of the test data included a qualitative evaluation of each test (Schmertmann 1986 or Diviney 1990). Schmertmann rated each data point as either very good, good, fair, or poor. A subjective weight equal to 1.0, 0.5, 0.25 or 0, respectively, was assigned to each data point in this study according to Schmertmann's rating. These subjective weights are designated as p_i in subsequent equations.

Figure 6. Horizontal stress from pressure meter and hydrofracture testing at Eisenhower Lock

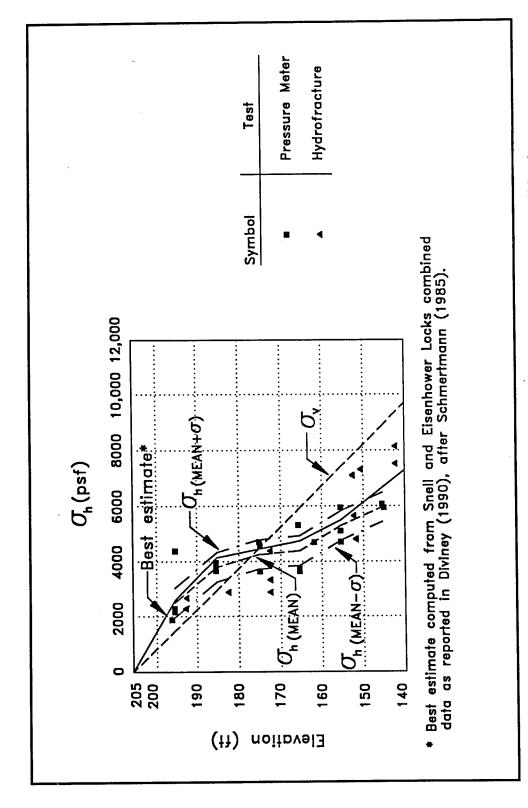
Figure 7. Horizontal stress from pressure meter and hydrofracture testing at Snell Lock

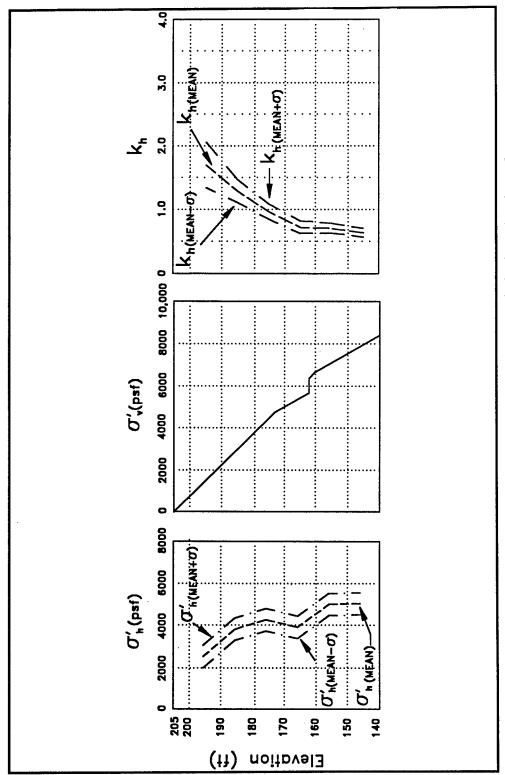
Figures 10 and 11 shows the mean, mean plus standard deviation, and mean minus standard deviation of the horizontal effective earth pressure σ'_h for the two locks. The corresponding horizontal earth pressure coefficient K_h distributions are also shown in these figures.

Figure 10. Distribution of σ'_h , σ'_v , and K_h with elevation from statistical evaluation of pressure meter test data at Snell Lock

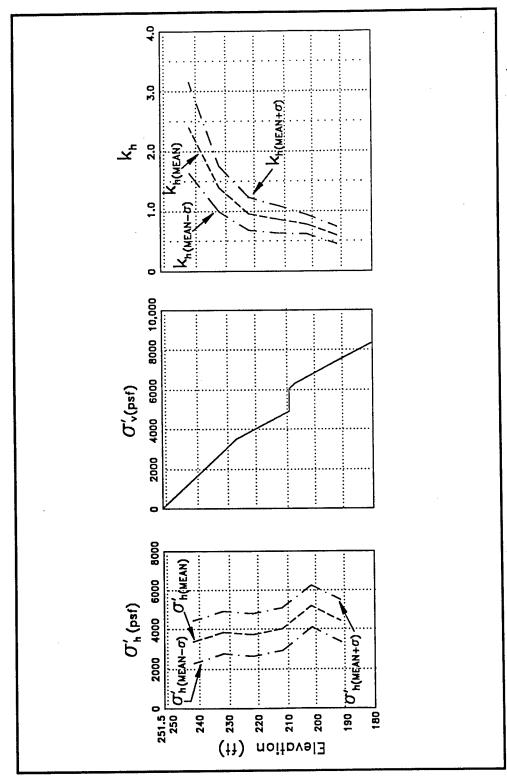
Figure 11. Distribution of $\sigma^{'}_h$, $\sigma^{'}_v$, and K_h with elevation from statistical evaluation of pressure meter test data at Eisenhower Lock

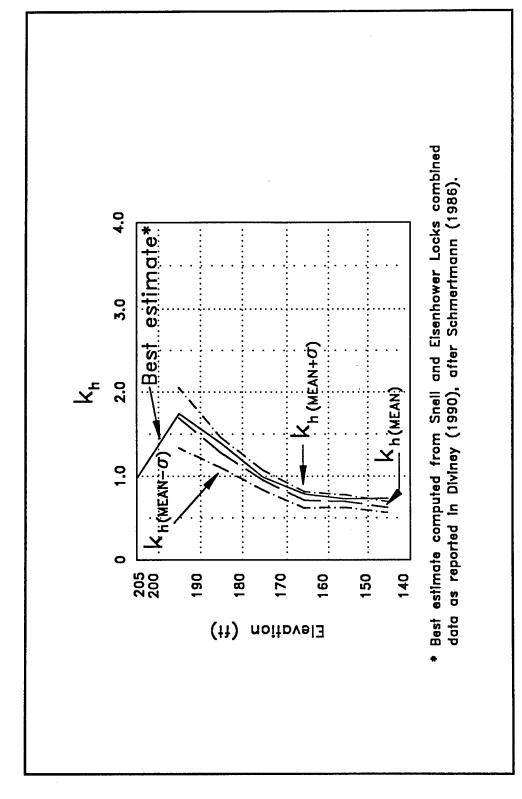
Figures 12 and 13 show the statistical evaluations made in this study in terms of K_h for the two locks to be in agreement with the best estimate reported in Diviney (1990) after Schmertmann (1986). Recall that their

Distribution of K_h with elevation from statistical evaluation of pressure meter test data at Snell Lock Figure 12.

best estimate was computed using combined data from Snell and Eisenhower Locks.

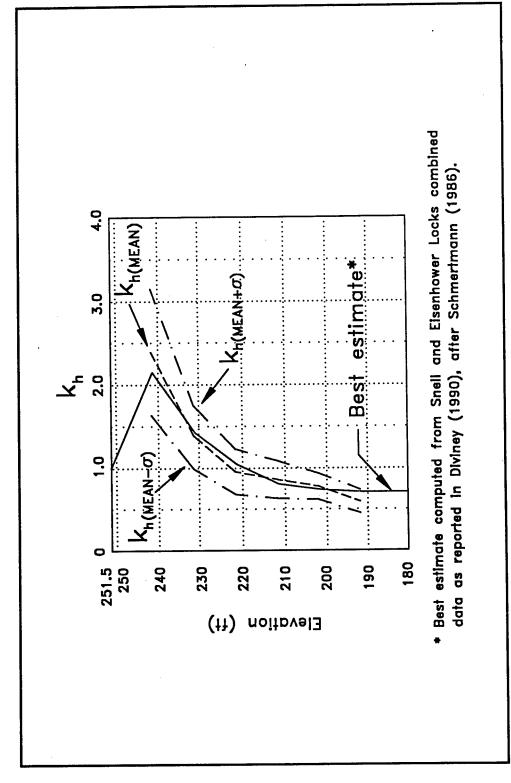
Figure 13. Distribution of K_h with elevation from statistical evaluation of pressure meter test data at **Eisenhower Lock**

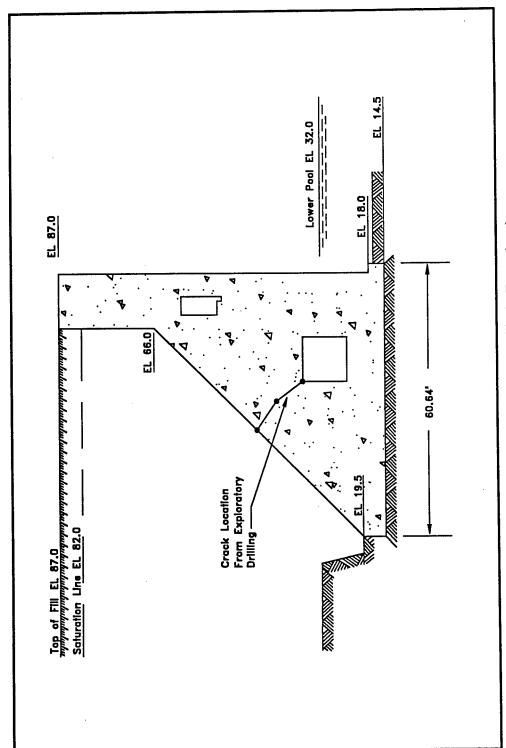
Miller's Ferry Lock had been in service for almost 25 years when a problem was detected in April 1990. During an inspection of the lock, Mobile District personnel discovered that water had been escaping behind the upper valve monolith 6L. This indicated that there might be a crack in one of the filling culvert monoliths. This was confirmed by further observation of upstream monoliths 5L and 4L, which were misaligned relative to the remainder of the lock chamber by almost 1/2 in. (USACE 1993).

The investigation to examine the location and extent of the crack was conducted in two phases. The first phase involved the drilling of exploratory holes through the esplanade into monoliths 5L and 4L. The exploratory drilling was used to map crack width and direction in each of the monolith sections. The second phase used an underwater video camera to confirm the crack location from inside the culvert. The video showed that there was a continuous crack through the top corner of the culvert to the back of the monolith. However, it appeared that the flows in the culvert were not very high and had not reached extreme levels. From both phases of the investigation, the Mobile District concluded that the crack in the culvert was at an approximate 45 degree angle to the outside faces of the monoliths (USACE 1993). Figure 16 shows the location of the crack within monoliths 5L and 4L.

Piezometer readings in the backfill indicated that the saturation line (or phreatic surface) could range from el 50 to el 65, depending upon the season. However, in March 1990 a flood occurred on the Tombigbee River and the flood stage reached el 83. At this time, the saturation level in the backfill moved up to approximately el 82 due to the low permeability of the fine materials in the backfill. It appears that this flood event triggered or exposed the cracking problems at Miller's Ferry, which were discovered during the inspection in April 1990.

Figure 16. Location of crack in monoliths 4L and 5L at Miller's Ferry Lock

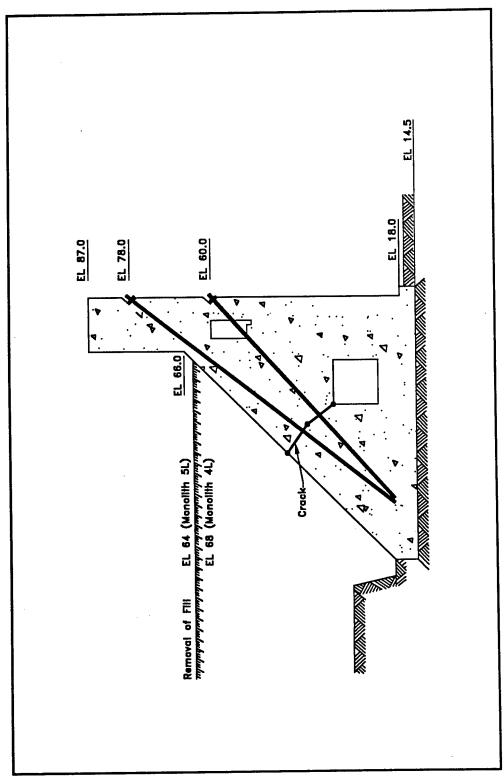
Figure 17. Typical installation of anchors and remediation of soil at Miller's Ferry Lock

The rehabilitation of the cracked monoliths sections was accomplished by the installation of post-tensioned anchors. Nine tension anchors, each containing twelve 0.6-in.-diameter strands, were used to rehabilitate the structure. The design load for the anchors was 422 kips. Figure 17 shows the typical anchor installation. After placement of the anchors and lockoff in March 1991, there was serious concern that the anchors would hold only approximately 60 to 70 percent of their design prestress (USACE 1993). However, in a liftoff test in October 1991, all the nine anchors held about 100 percent or more of their design prestress.

After the anchors had been installed, the cracks in the culverts were sealed with a grout mixture. This grouting mixture in the crack helped to maintain a continuity of the contacts between the two separated surfaces. This was accomplished by divers using an insert drilled into the upper left corner of the culvert that pumped the grout into the crack. The insert holes were then later filled and sealed with an epoxy sealer. This grouting process was successful, but it did take more than one attempt to stop the flow. Even today the grout does cut off most of the culvert flow into the backfill even though some water may still be present at times behind the monoliths (USACE 1993).

The site was also remediated by the removal of material behind the affected monoliths to lower elevations. The backfill behind monolith 4L was lowered to el 68 and to el 64 behind monoliths 5L and 6L. The option of removing material and replacing it with a much freer draining material was discussed. However, it was ruled out due to the increased expense. The total cost of this remediation/rehabilitation was around \$473,000.00, in 1991 dollars.

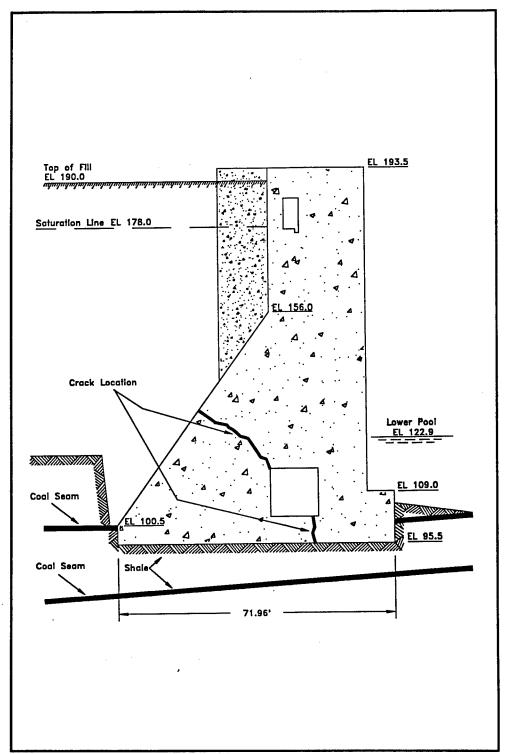
The crack in monolith 6L extended horizontally across the section at el 148.5. The crack was completely open, and staining was present at the downstream end. The upstream end was closed and had not yet stained. The crack in monolith 7L was located between the top of culvert and the back face of the monolith near el 120. Continued drilling across the monolith indicated that the crack was at a 45 degree angle to the backface (USACE 1991). The crack opening was about 3/8 in. and allowed a flow that ranged from 100-500 gpm. Figure 20 shows the crack locations for monolith 7L.

Figure 20. Locations of cracks in monolith 7L at Holt Lock

Recent inspection of the structure (USACE 1985) has revealed 4- to 5-in.-diameter boils at the surface of the backfill about 10 ft from the lock wall behind monolith 7L and 8L joints. The relief drains flow is less than 5 gpm and usually clear. Lock uplift cells 7,8, and 9 are present in monolith 6L, but appear to be clogged because they tend to give readings higher than the upper pool elevations. A stability analysis was conducted by the Mobile District on the chamber structures. The results indicated that the lateral earth pressure coefficients were in the range of 0.8 to 1.0 would result in the cracking of the monoliths (USACE 1981).

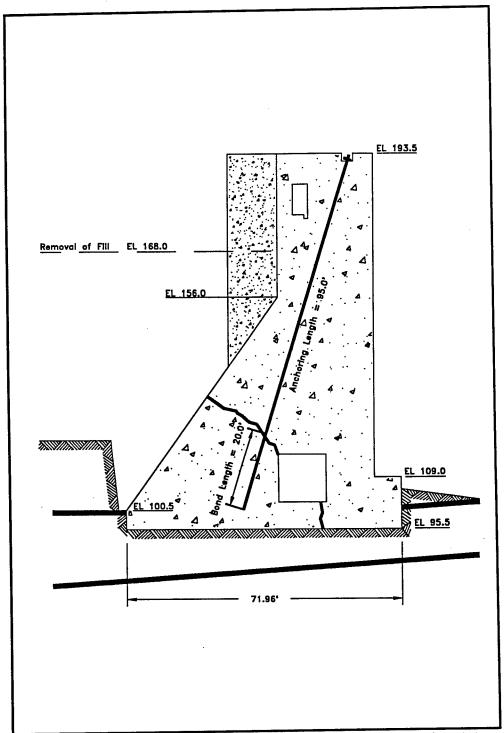
Figure 21. Remediation and typical installation of anchors at Holt Lock monolith 7L

Stability analyses indicate that an at-rest earth pressure coefficient around 0.8 to 1.0 would not meet current Corps design criteria for stability and result in cracking of the monoliths at Holt Lock. The rehabilitation and remediation of Holt Lock was accomplished through the use of post-tensioned anchors and the removal of about 25 ft of soil from behind the filling chamber monoliths.

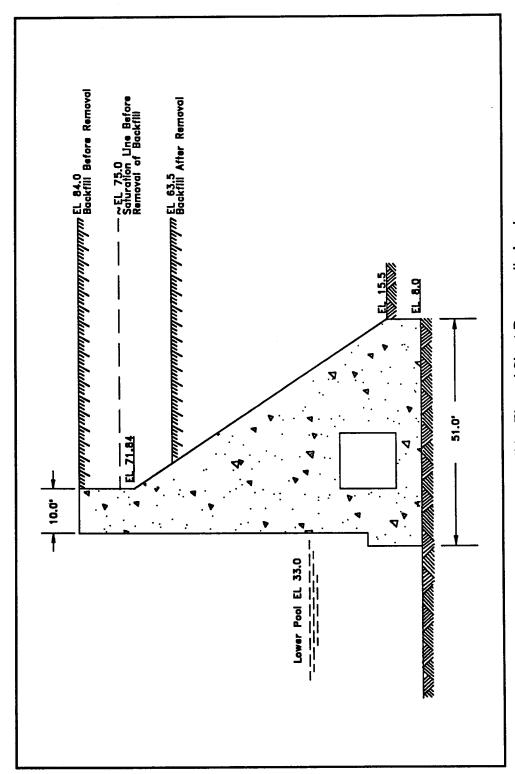
The remediation of Demopolis Lock was crucial in preventing any future cracking of the chamber monoliths. The material compacted behind the lock walls was a silty sand material. This backfill permitted the water table behind the lock walls to be retained at or near upper pool elevation. This was a concern given previous cracking problems at similar locks in the region. Stability analyses were performed by the Mobile District (1992) using an at-rest earth pressure coefficient K_o of 0.7. In order to maintain the current Corps of Engineers criteria for stability, the remediation of almost 20 ft of backfill from behind the chamber monoliths was required.

Figure 24. Remediation of backfill at monoliths 7L and 8L at Demopolis Lock
